MIDLOTHIAN FLOODING ANALYSIS

Erin Maloney
Hydraulic Engineer
Chicago District
3/12/2015

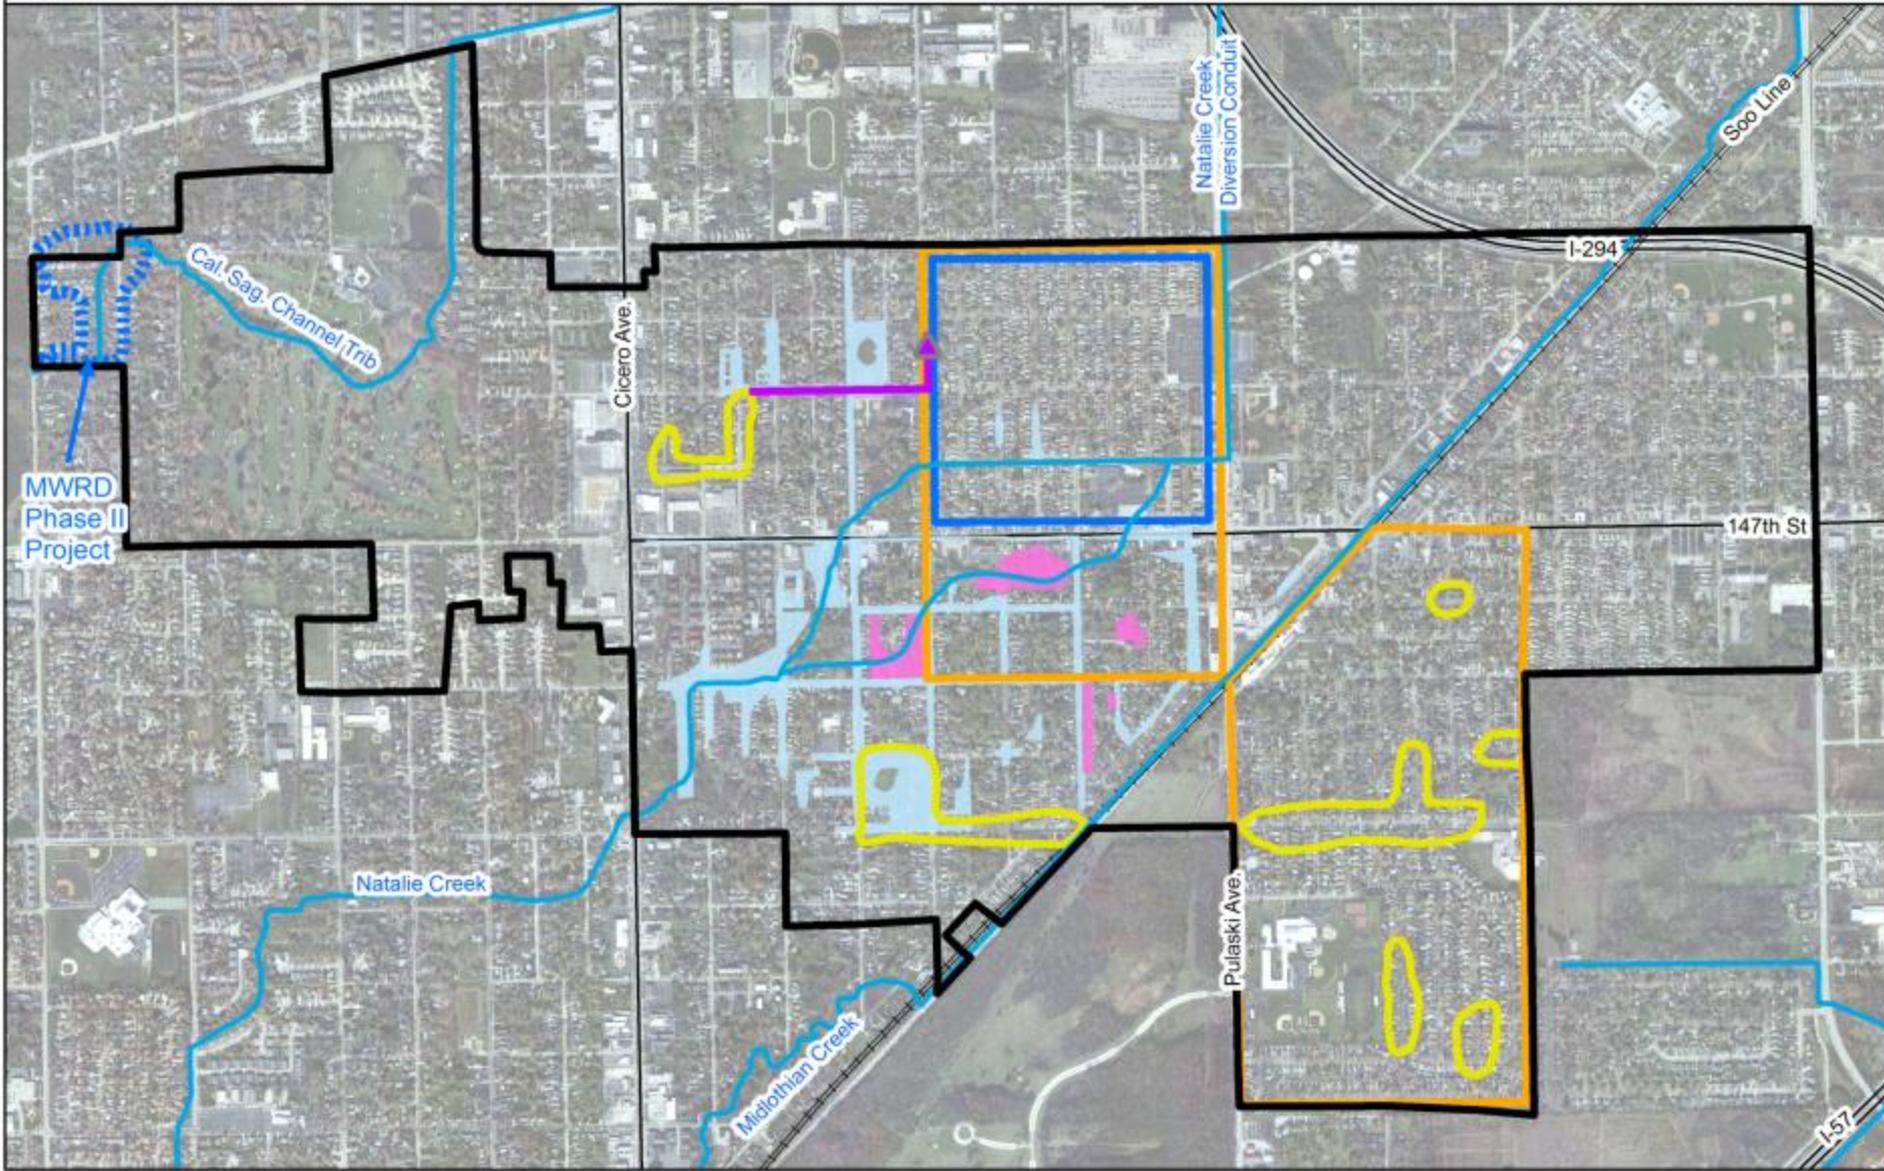
Summary of Known Problem Areas

By Village:

Ditch overtopping issues

Sanitary Sewer Backup

Storm Sewer Backup

High Water Table

By Floodlothian:

Structure Flooding

Street/ Yard Flooding

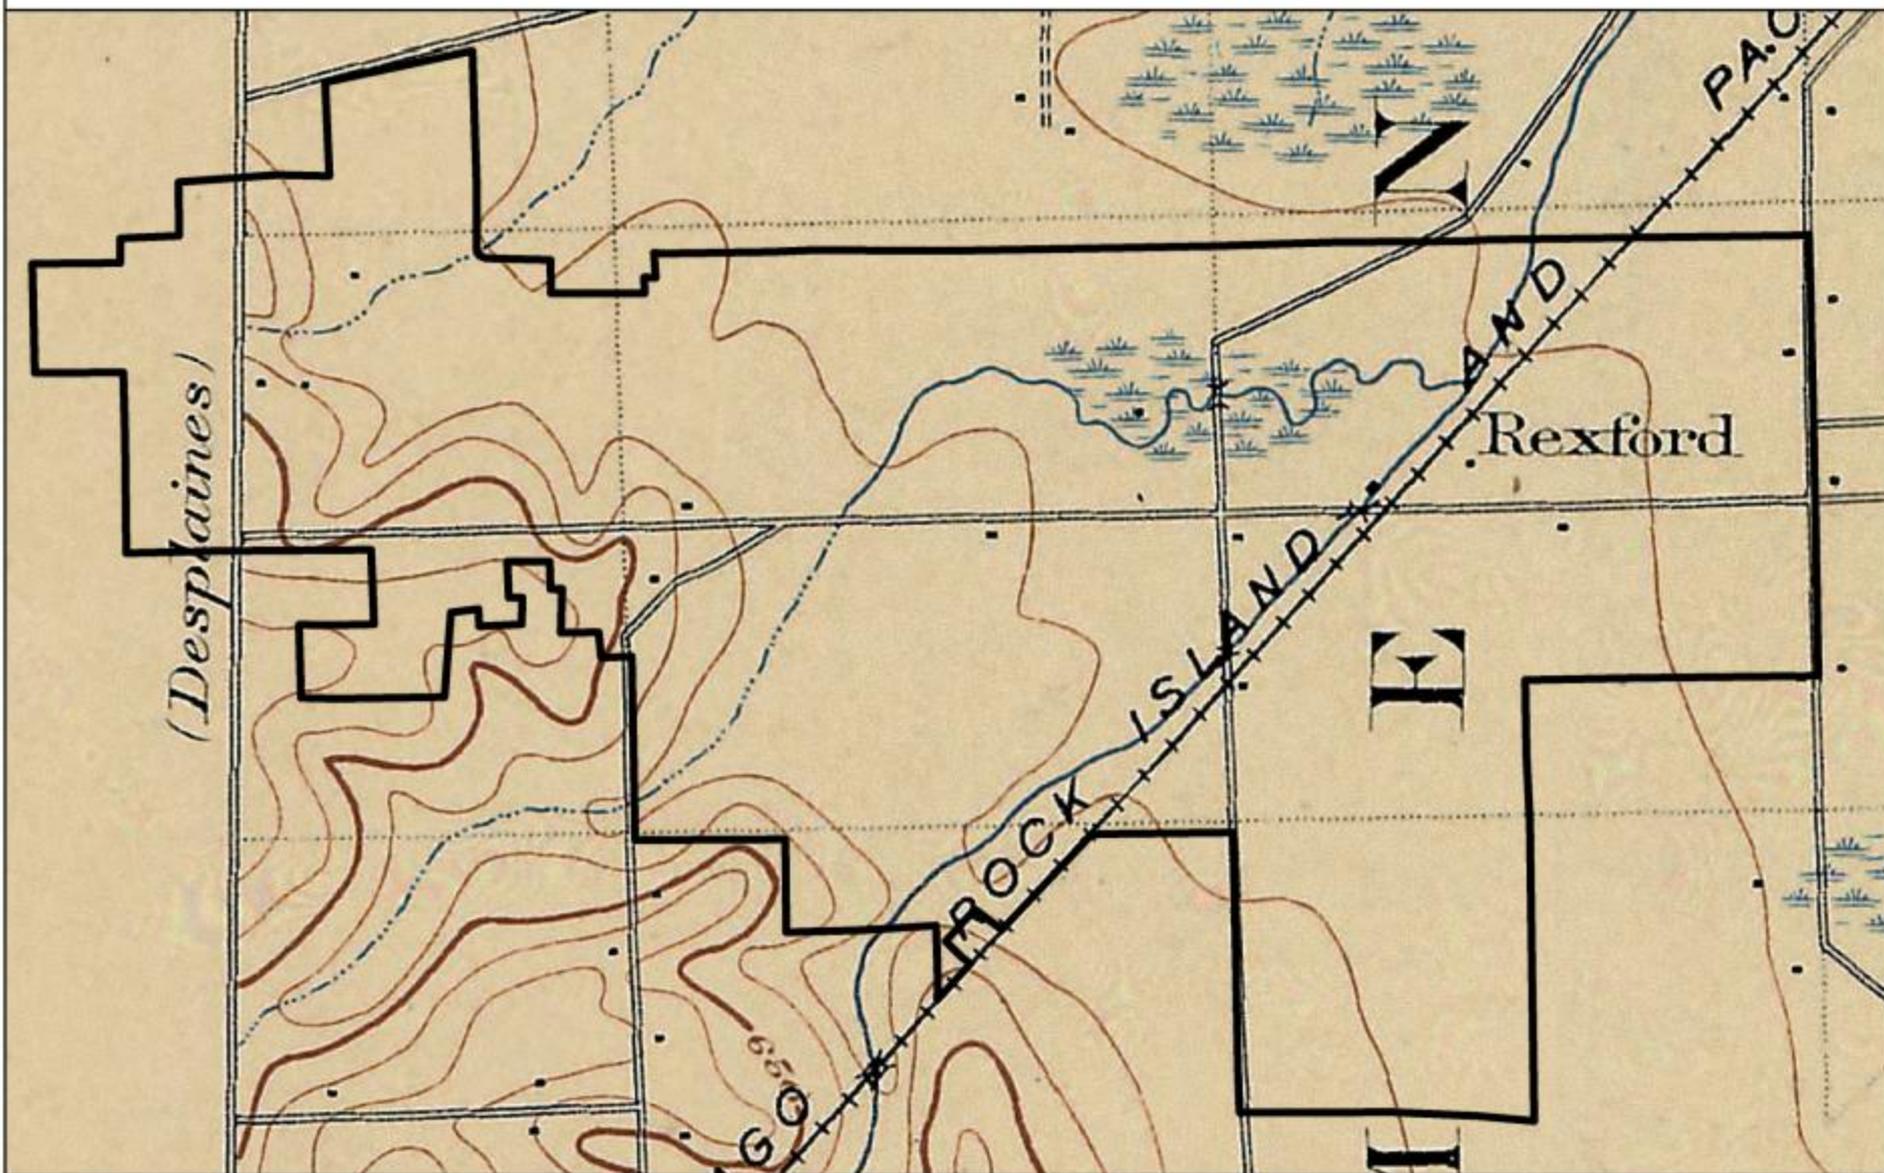
USGS Quad Map - 1901

10 foot contours

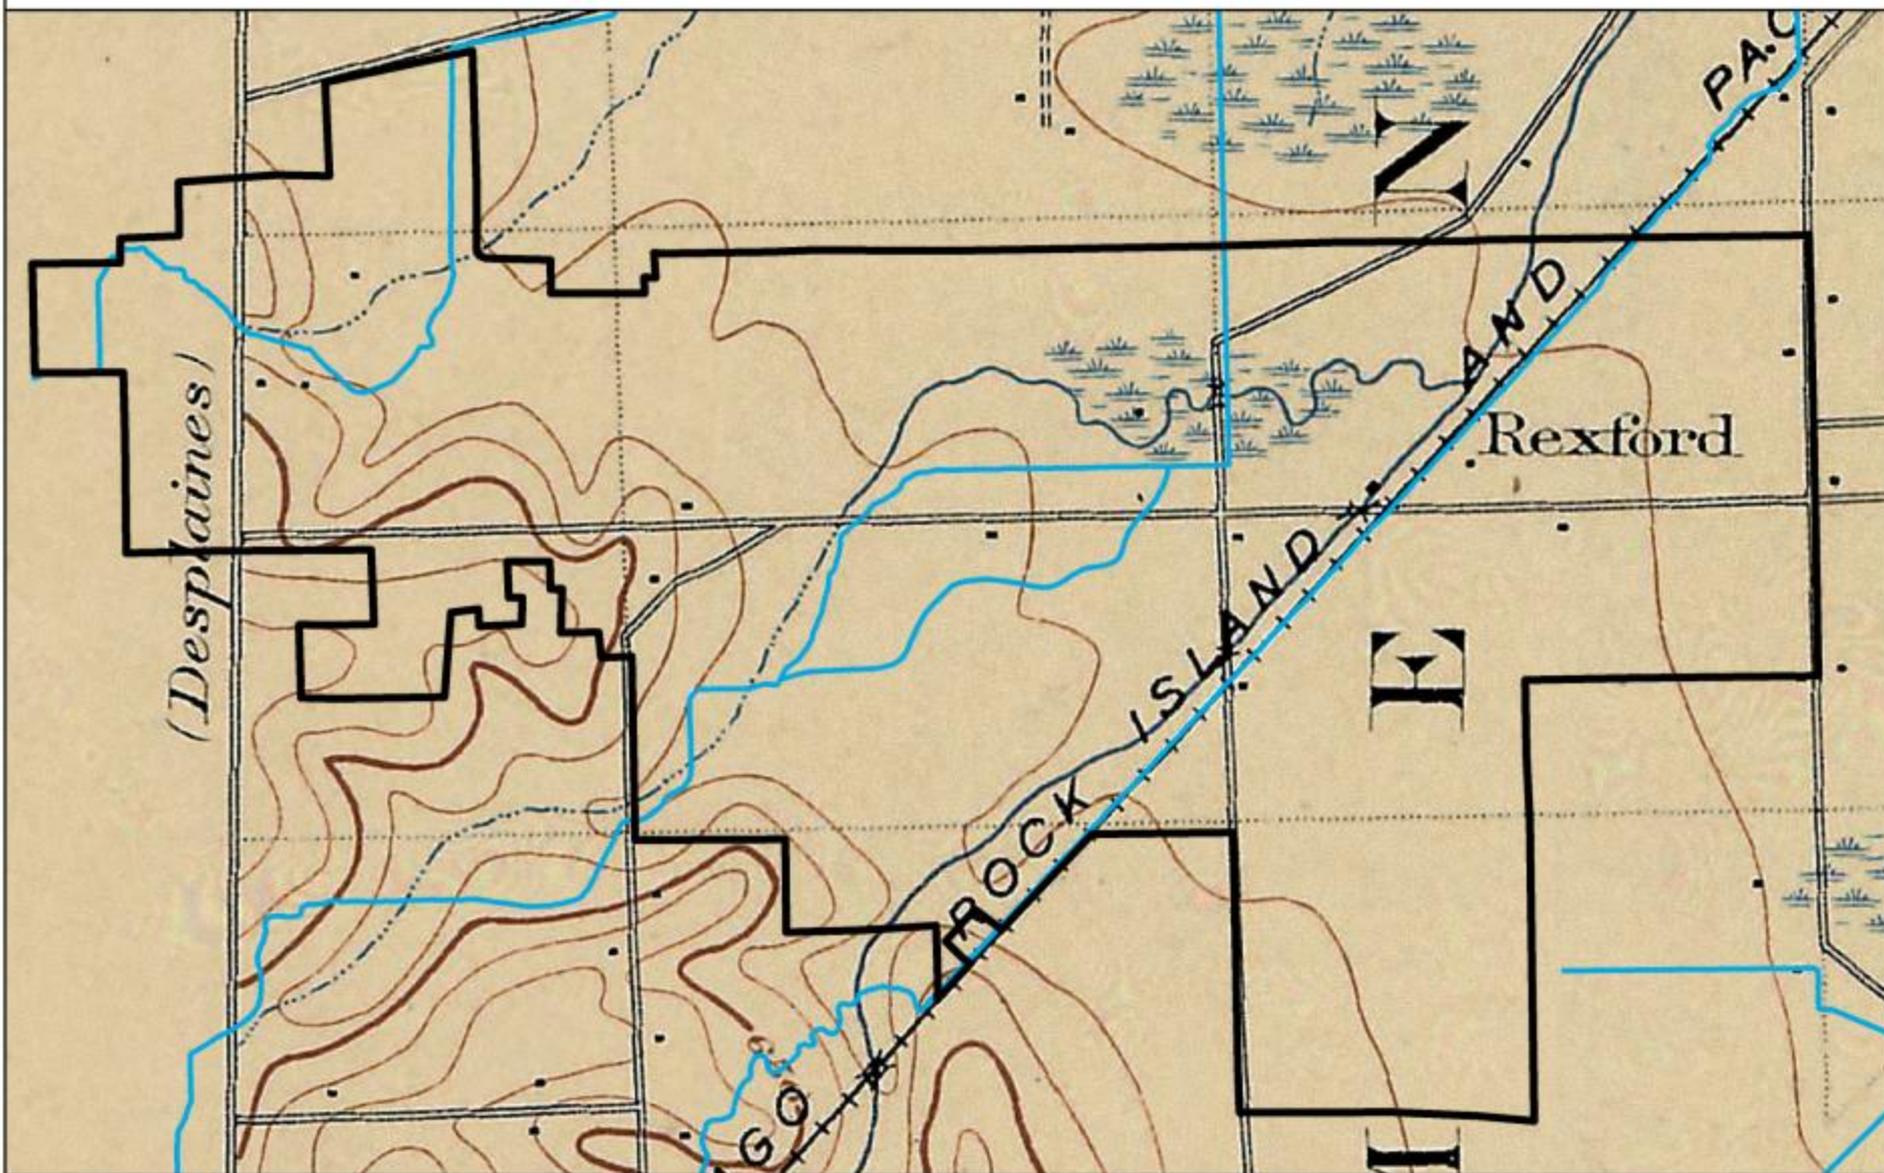
USGS Quad Map - 1901

10 foot contours

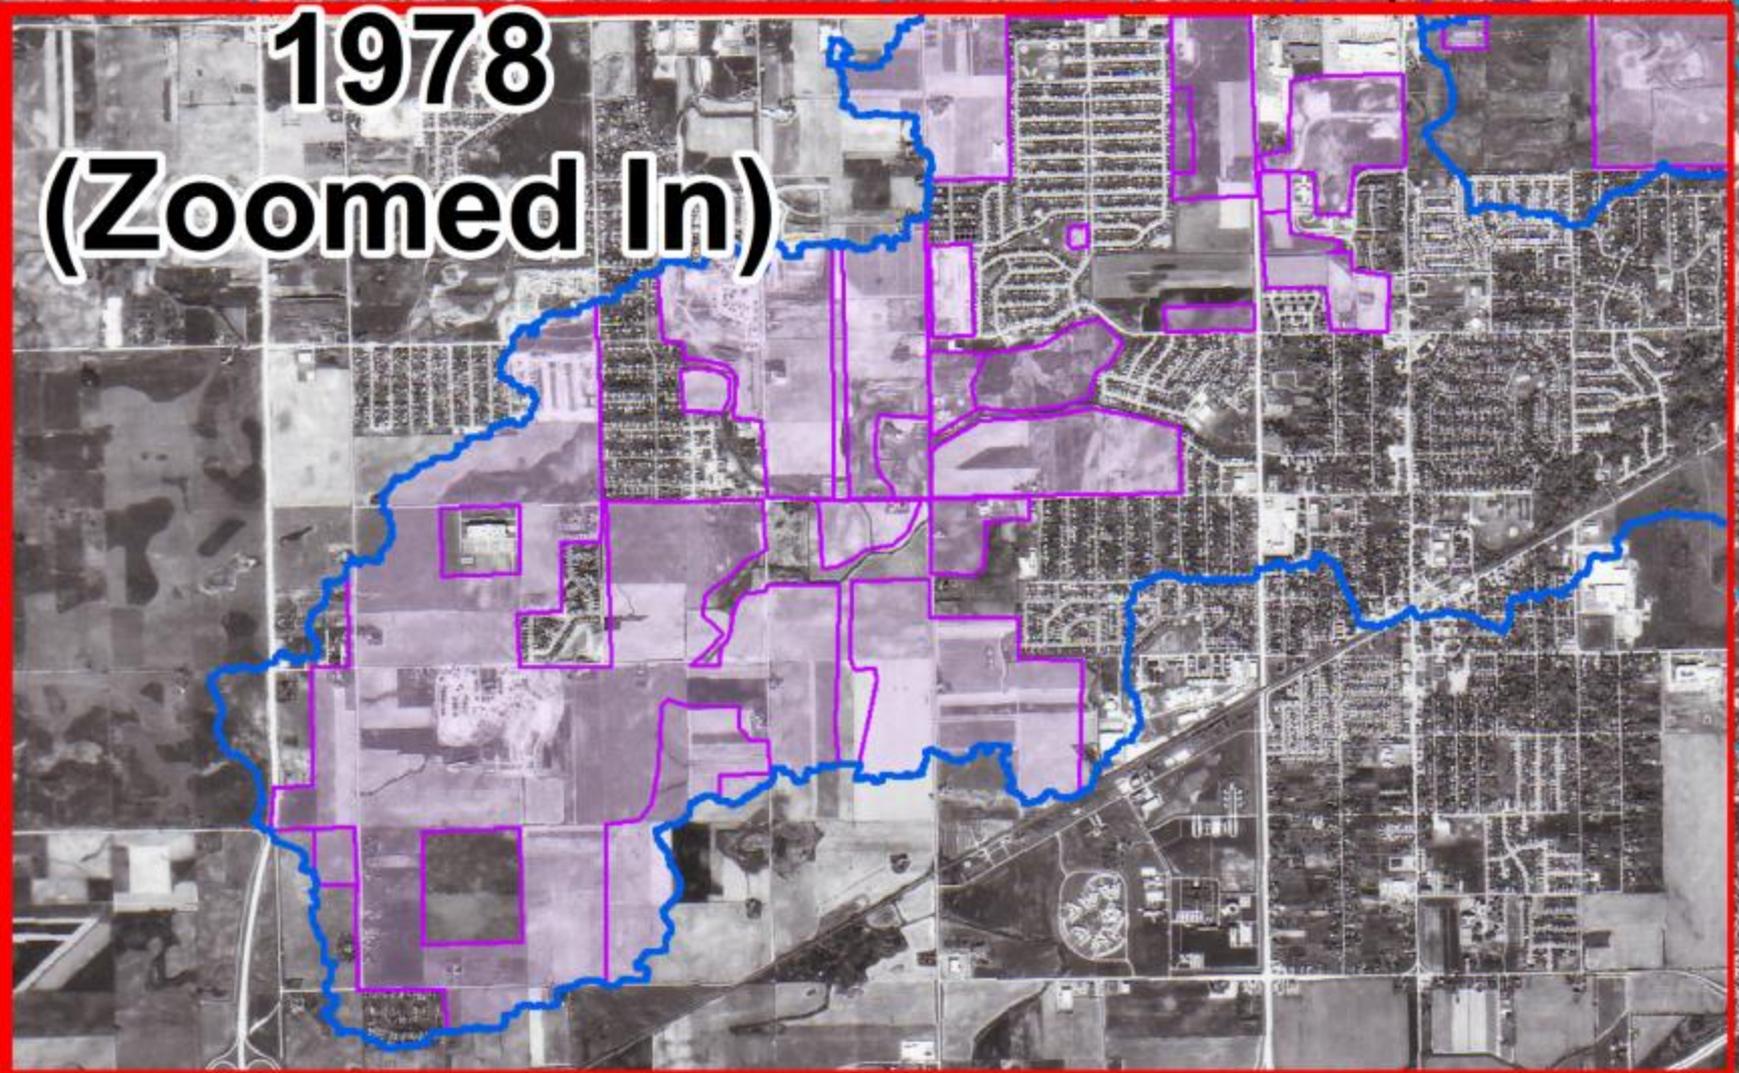
1978
(Zoomed In)

Development in Watershed Since 1978

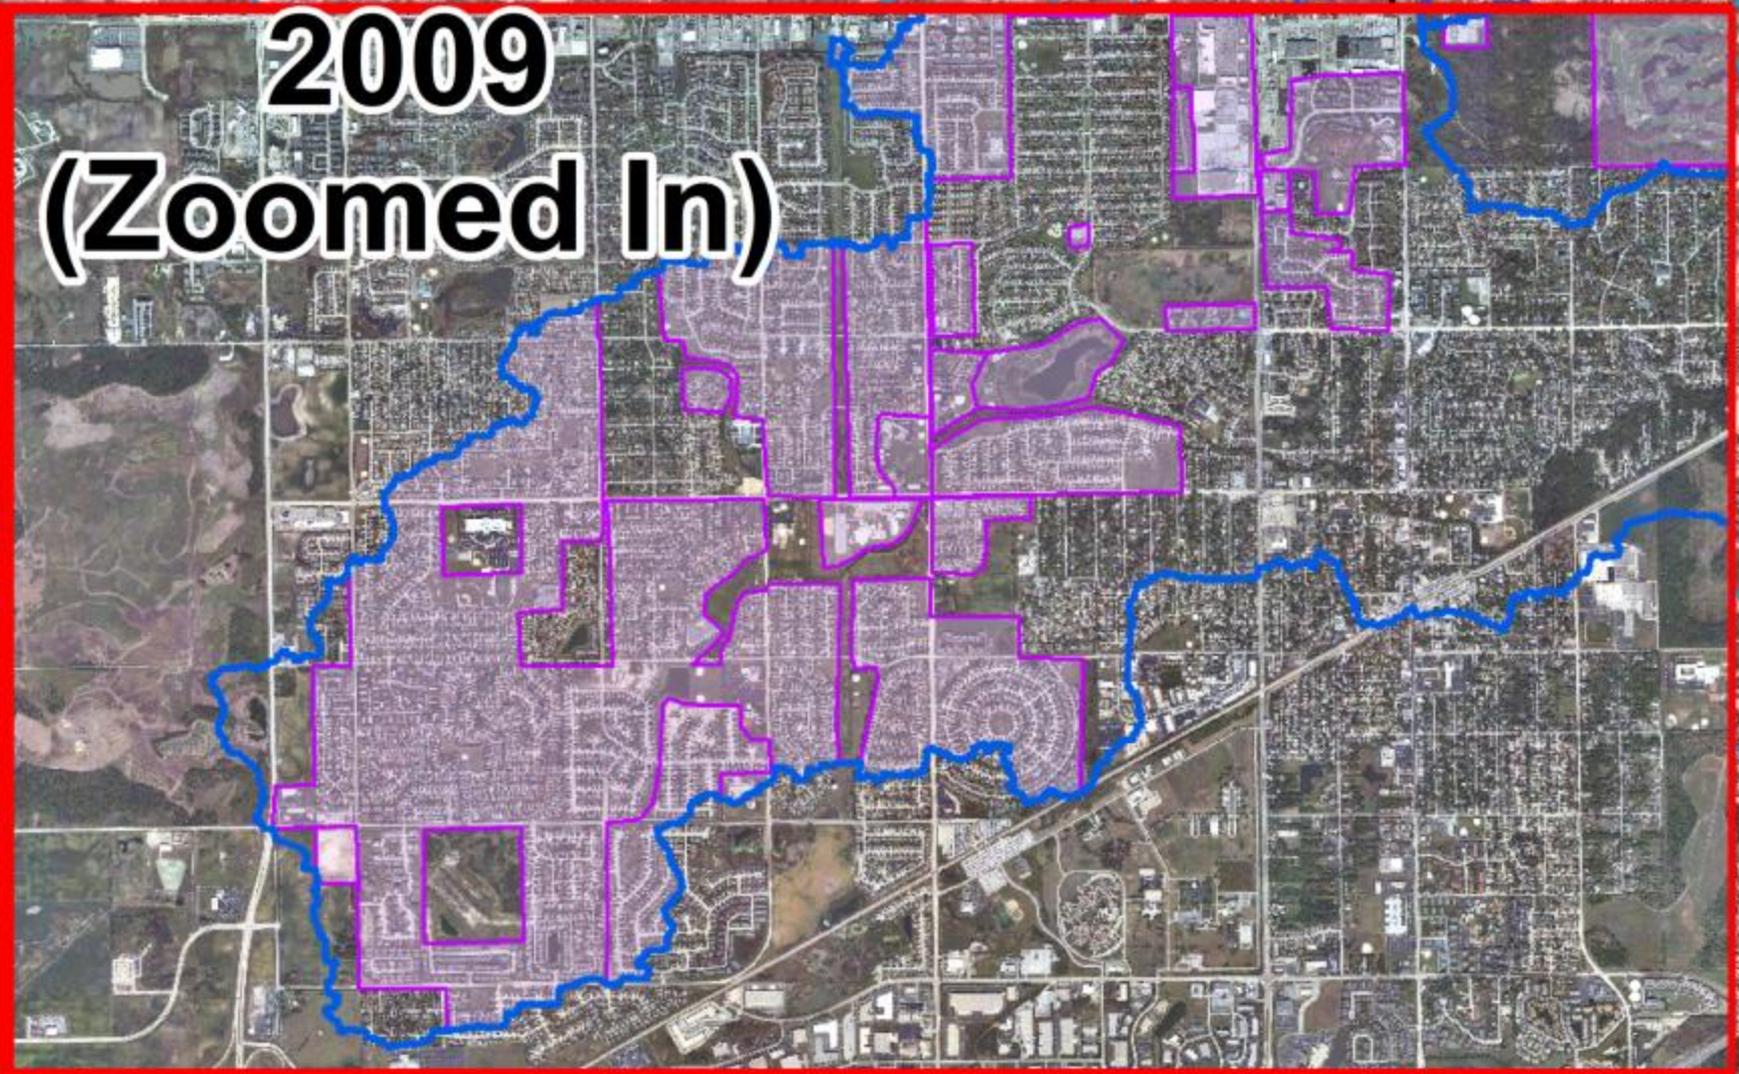
2009
(Zoomed In)

Development in Watershed Since 1978

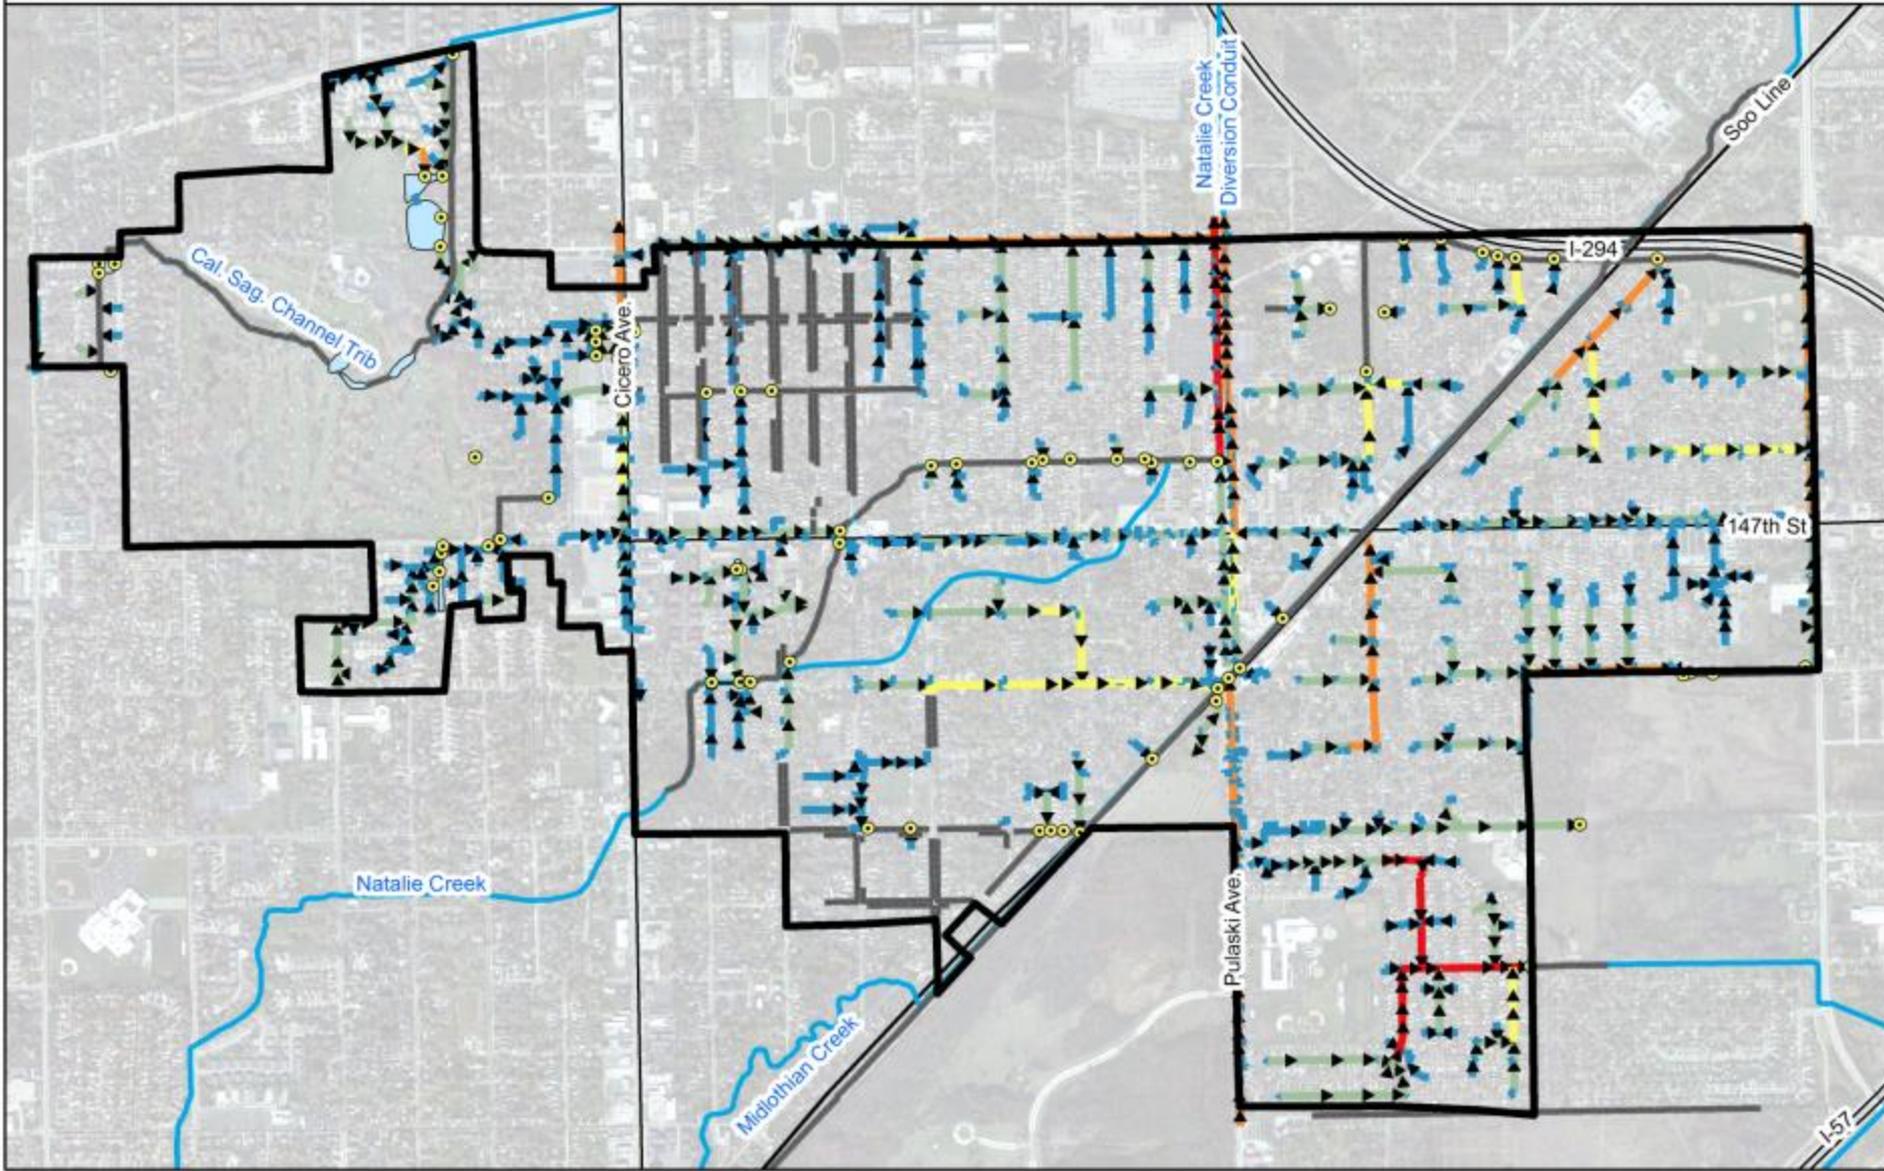
Storm Sewer Network

- Storm Sewer Outlet
- Pond
- Drainage ditches

Storm Sewer Size (Or equivalent)

- 6" - 12"
- 12" - 24"
- 24" - 36"
- 36" - 48"
- Large Culvert

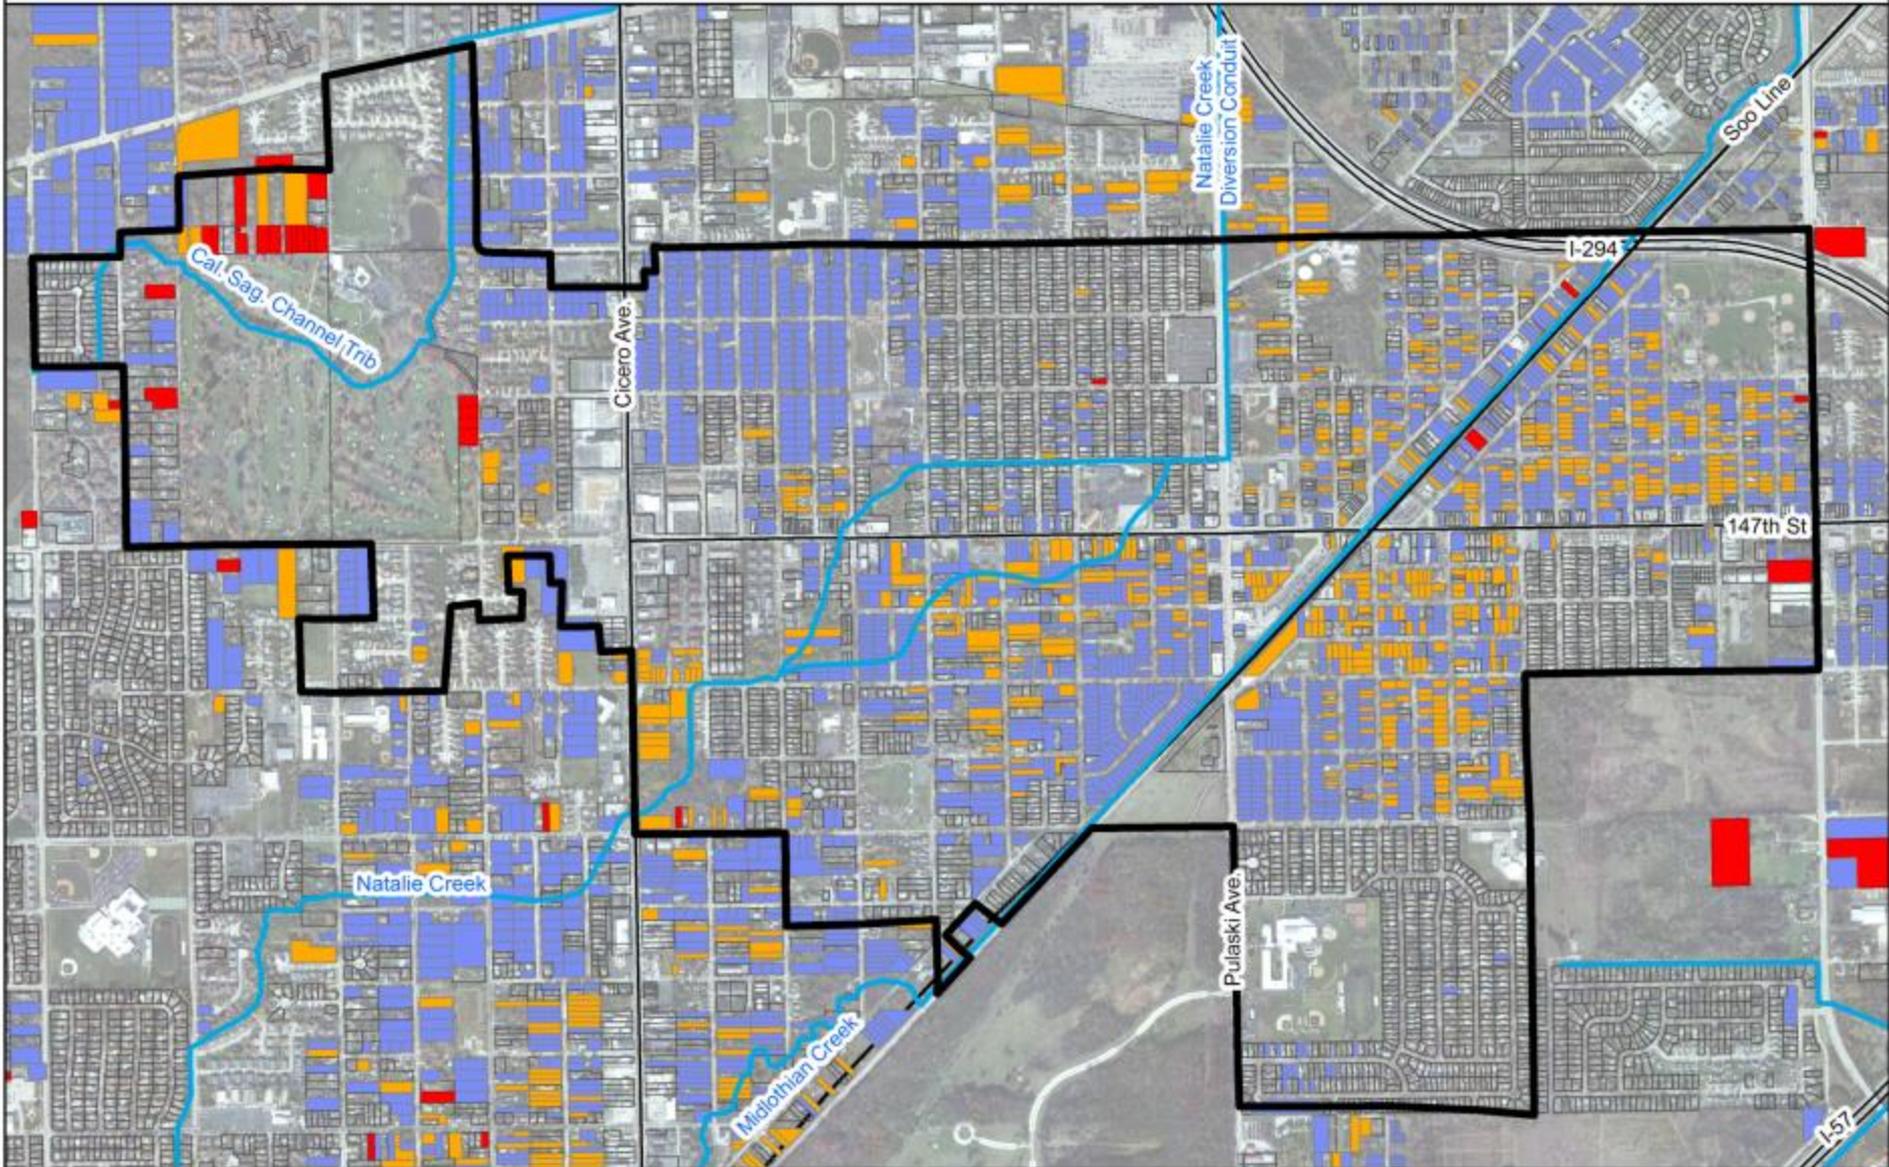
Approximate age of structure on parcel

(Less than 25 and unknown - not shown)

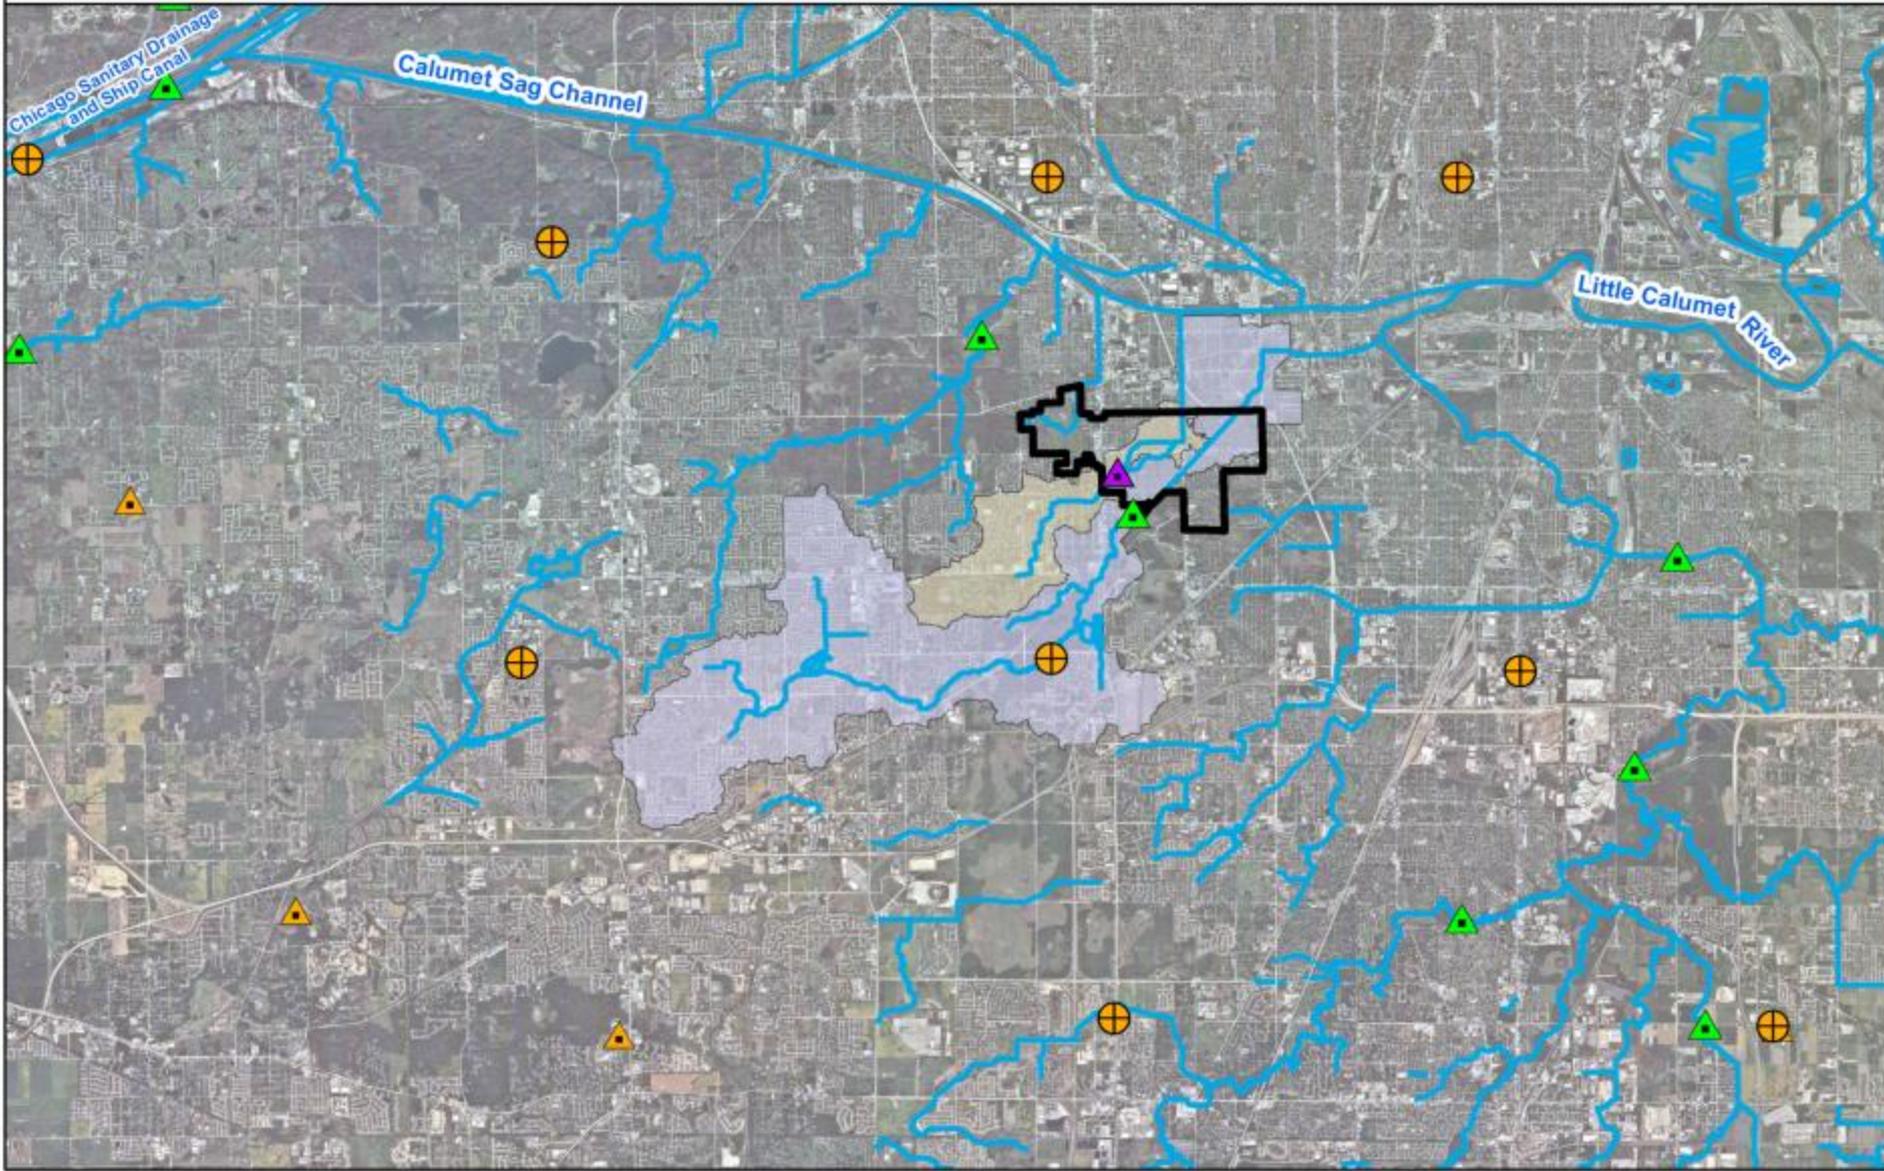
Rain and River Gages

⊕ Cook County Rain Gage

▲ USGS Rain Gage

▲ USGS Rain and River Gage

▲ USGS River Gage

Midlothian Creek Watershed

Natalie Creek Watershed

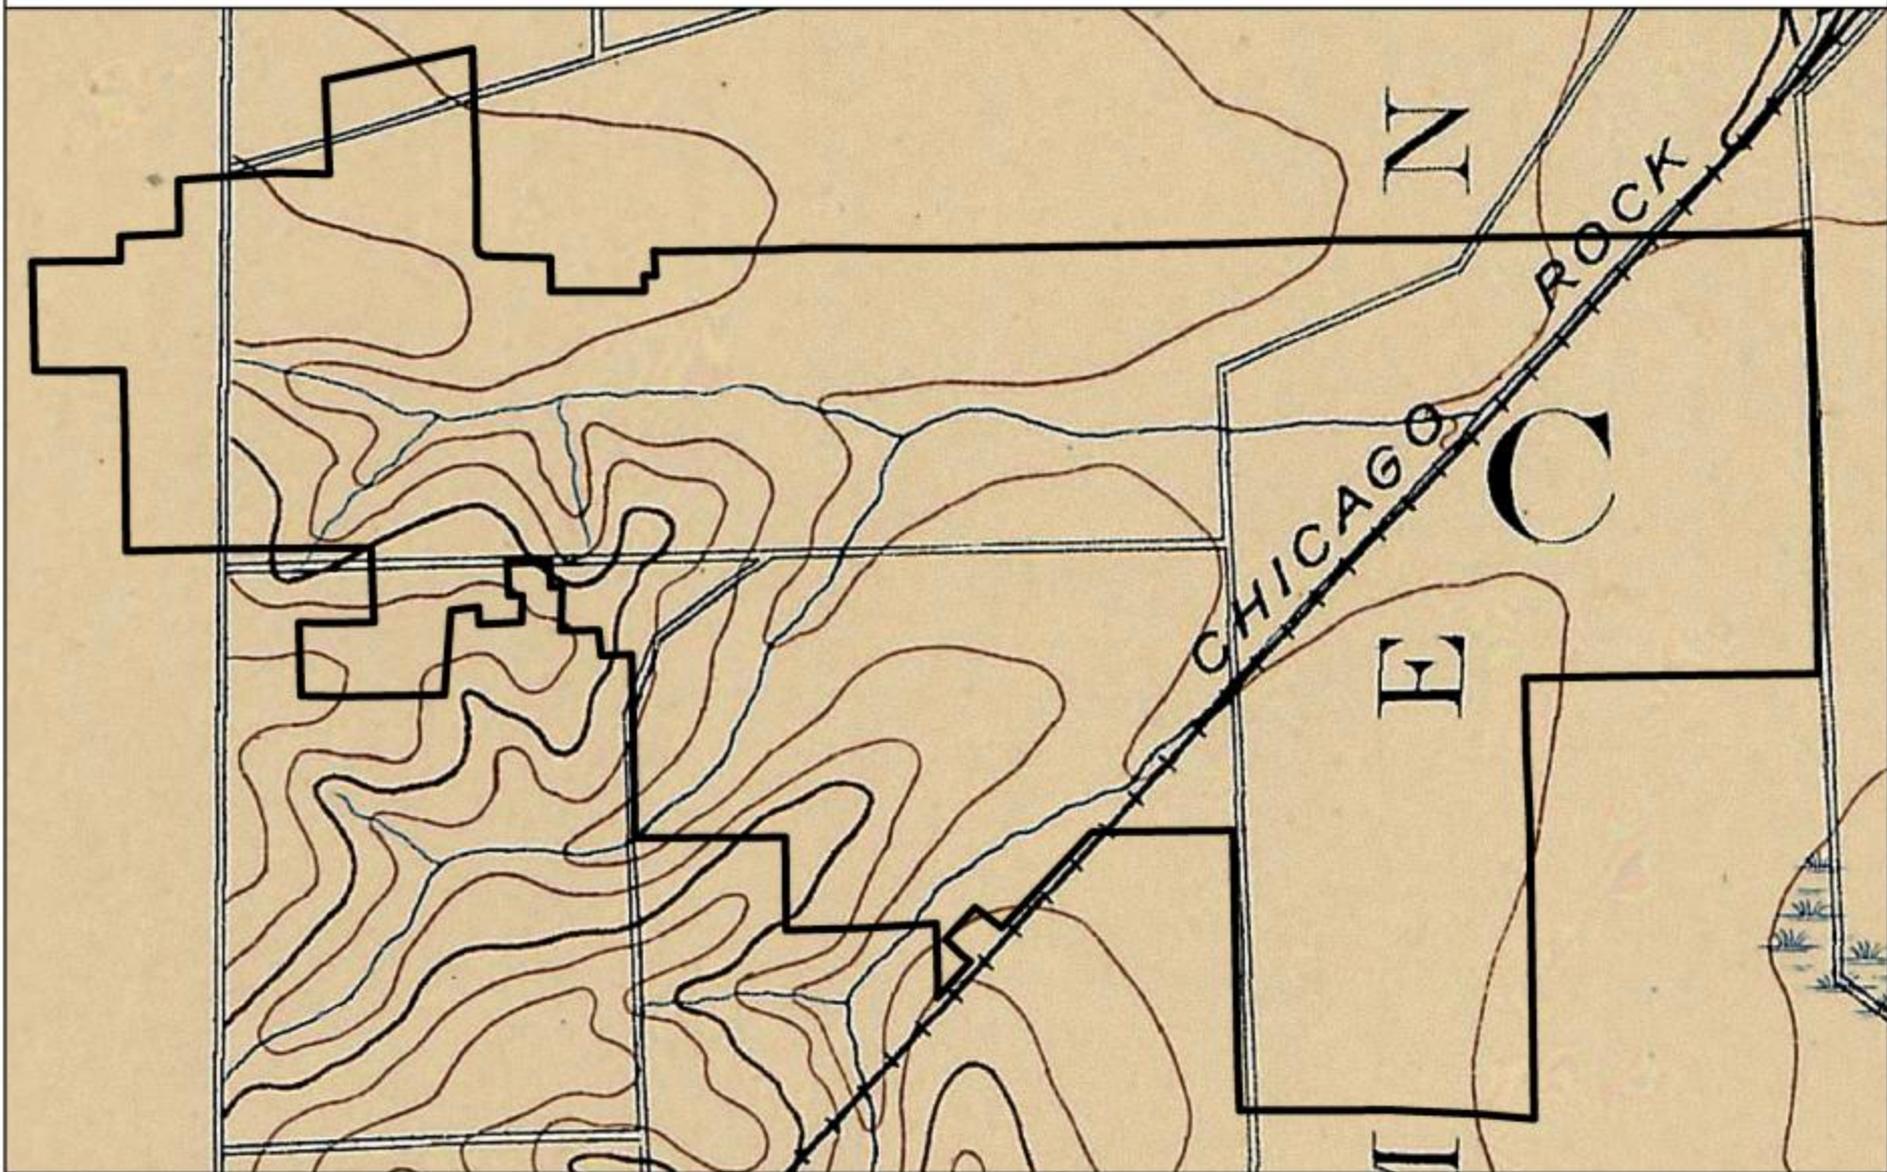
USGS Quad Map - 1892

10 foot contours

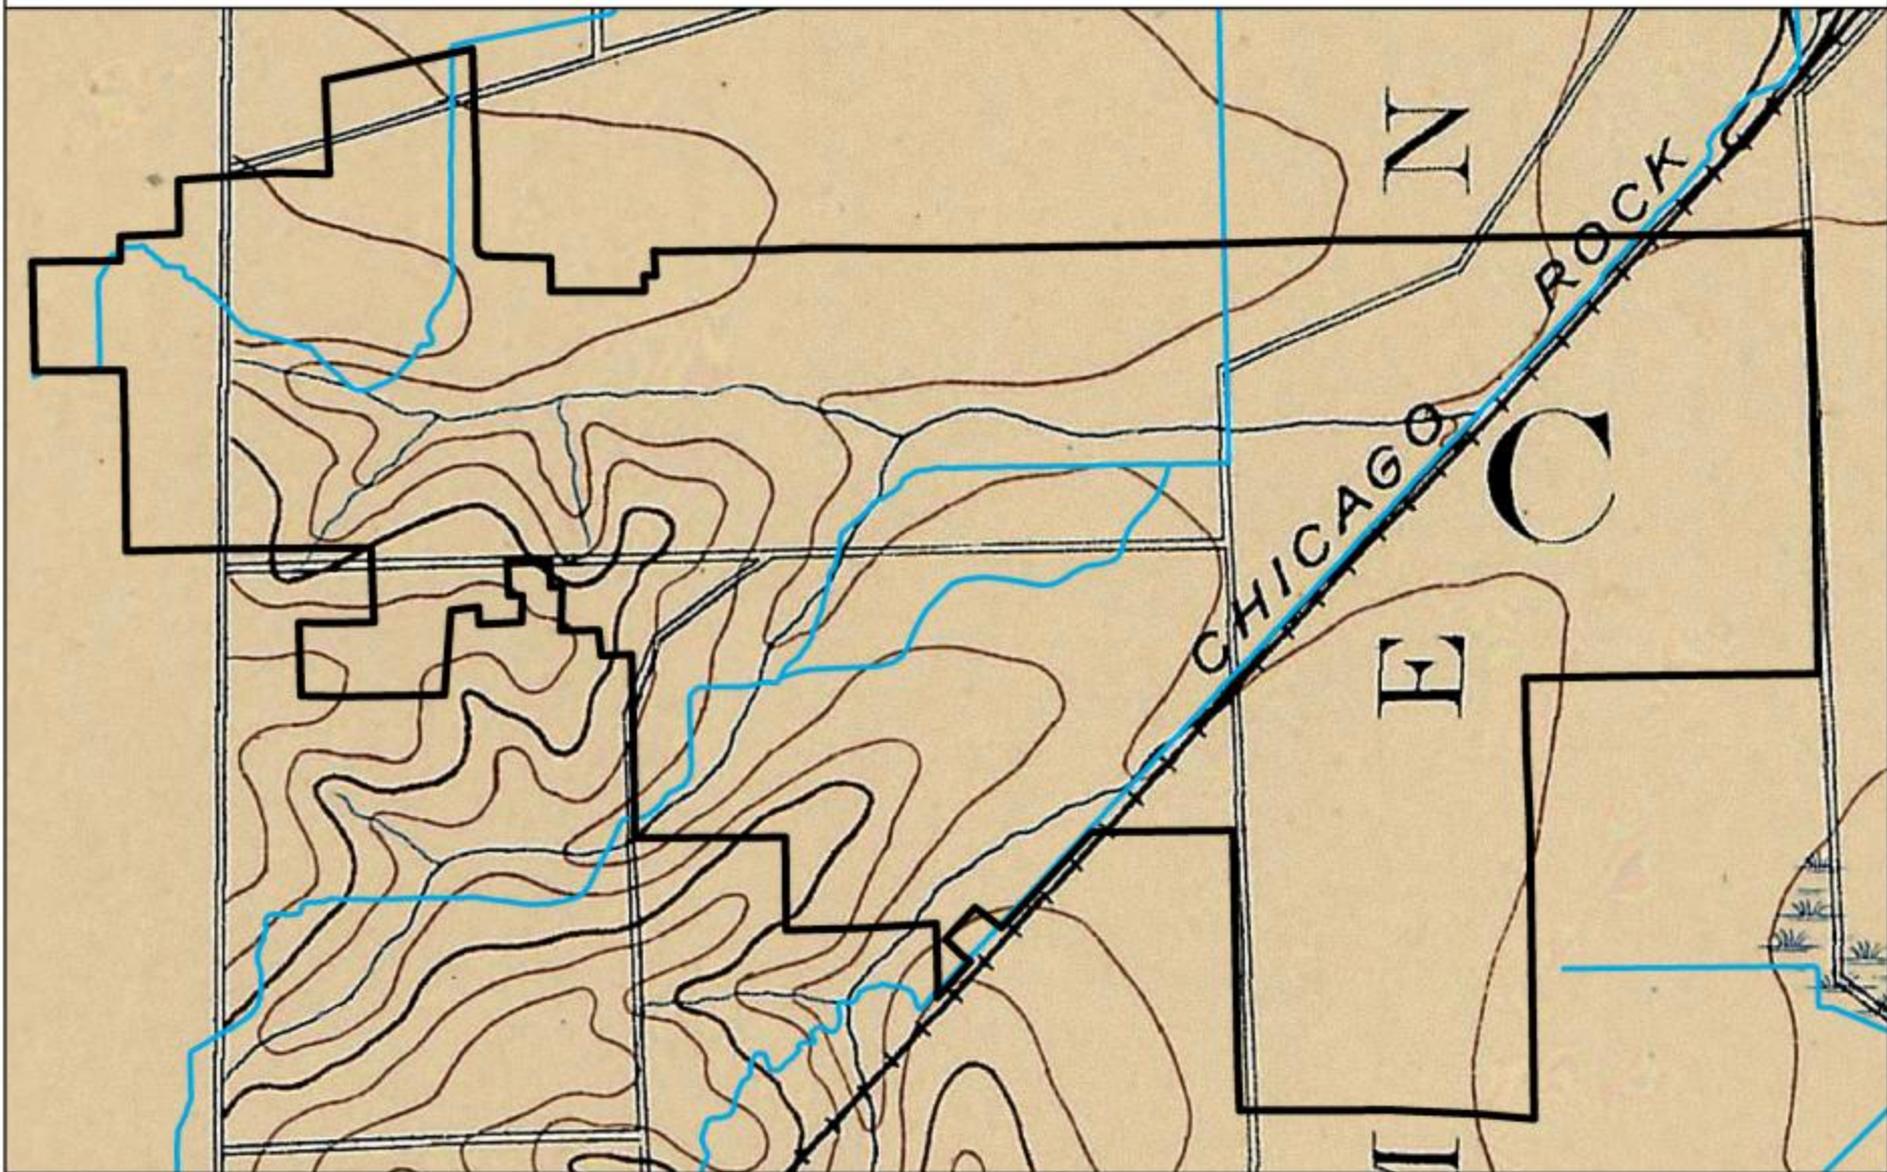
USGS Quad Map - 1892

10 foot contours
